Habitat Creation

Batheaston Reservoir reinstatement, Cotswolds AONB

Wessex Water

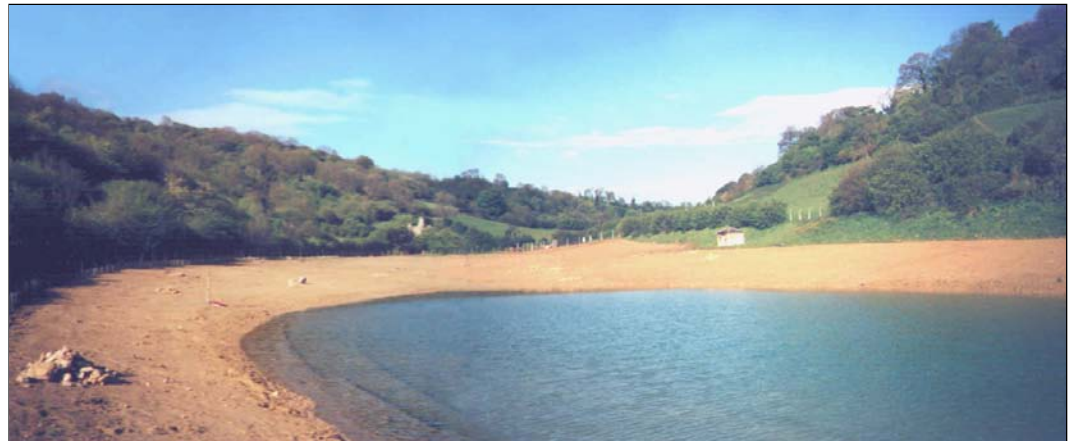
During

After partial demolition of structures the reservoir was filled with locally-excavated calcareous stony subsoil. Spring water, which flowed naturally through the site, was channelled to create two ponds within the filled reservoir basin.

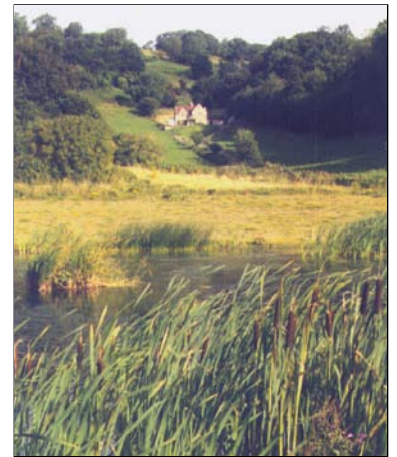
Initial establishment of the meadow was hampered by the poor structure of the subsoil and low nutrient levels, exacerbated by landfill compaction. Landmark employed innovative techniques to overcome these deficiencies. Soil structure was improved by adding 10,000 imported earthworms, which were distributed throughout the site in introduced piles of compost. Heavy application of fertiliser would have encouraged grasses to flourish at the expense of wild flowers, so soil fertility was gradually increased by adding 'Biogran', a by-product of sewage treatment. After 4 years of careful management, diverse flower-rich meadows have been successfully established, with over 36 species recorded. The tree and hedgerow planting is beginning to mature, helping the site to blend into its surrounding landscape, and the valley now has the added feature of two new ponds linked by an attractive stream.
